Ani in Context Workshop

September 28–October 5, 2013
Kars, Turkey

Foreword

Executive Summary

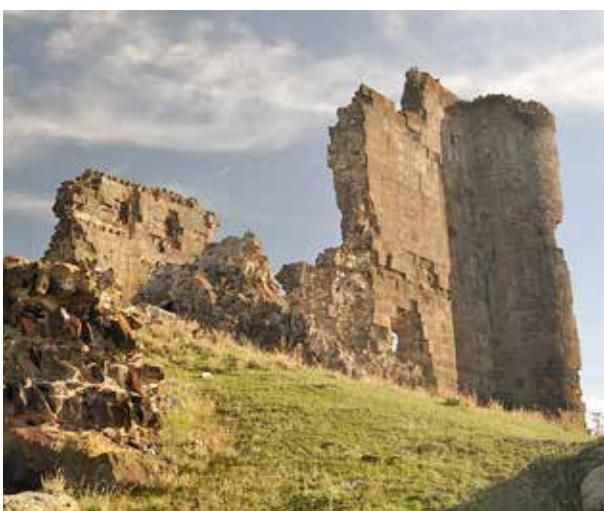
The fortress is in a ruinous state but some large wall sections remain standing.

Matrix Group 1—Requires immediate action. The wall sections that remain standing require urgent attention in order to stabilize them. The structure should be propped in areas where the support walls are missing as an emergency measure until more permanent repairs can take place.

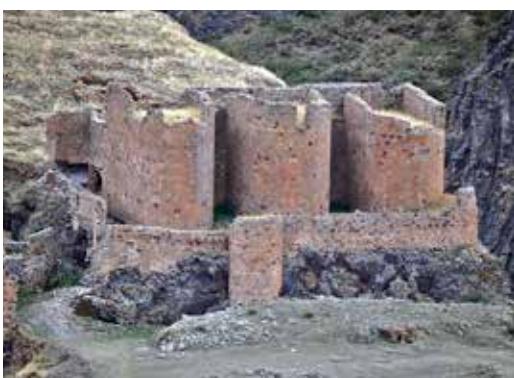
The site could not be accessed close up and therefore could only be inspected from one side at a distance of about 300 meters. The gate that is flanked by towers appears to be intact and the walls of the fortress are in relatively good condition. The settlement, however, is ruined. It was previously used as a garrison for the Turkish army and both the settlement and fortress are closed to visitors. A more detailed assessment of the condition can be determined after a visit and analysis by experts.

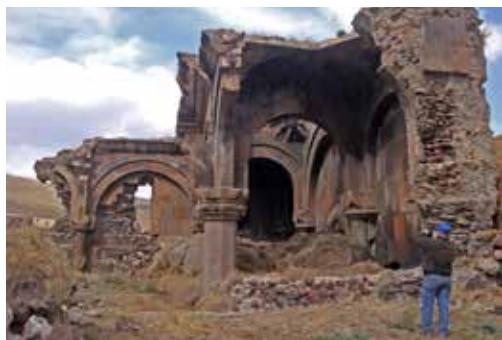
Photographic evidence from the early twentieth century shows the large complex of monastic buildings intact but damaged. In the decades since the middle of the century, however, most of the structures have deteriorated and have been lost. Currently, only one of the original buildings, Küçük Kozluca Church, remains more or less preserved. This six-foil domed church has lost all of the coverings, and almost all of the exterior stone blocks have been scavenged, but the structure remains intact. At the primary building of the complex, Surb Astvatsatsin Mon-

astery, the eastern and northern walls remain along with two columns and the ceilings of the eastern nave of the zhamatun, allowing us to understand the original design.

Matrix group 2—Possible eventual action. Küçük Kozluca Church, along with the zhamatun of the main part of the ensemble, is in need of urgent restoration.

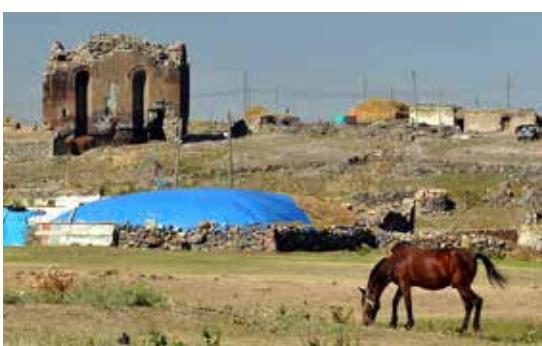
It is not clear if the remains of the partially standing church are registered or not. After medieval repairs, the church remained in good condition until the 1950s when it was partially blown up and most of the destroyed portions were removed from the site. Among the removed portions was a unique relief over the south doorway. Presently, only portions of the walls remain standing. There are signs of illegal excavation around the church and the walls have holes in them, indica-

Matrix Group 2—Possible eventual action. The site of the church requires excavation and the preserved part of the building needs conservation.

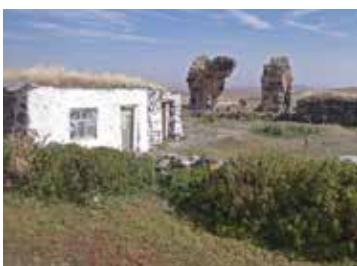
The building is ruined and the fragments are in a dangerous condition. Nevertheless, the floor plan and the main shapes of the arms of the cruciform structure are distinguishable. The ruins consist of part of the preserved window archivolts with carving.

Matrix Group 2—Possible eventual action. The ruined church requires conservation.

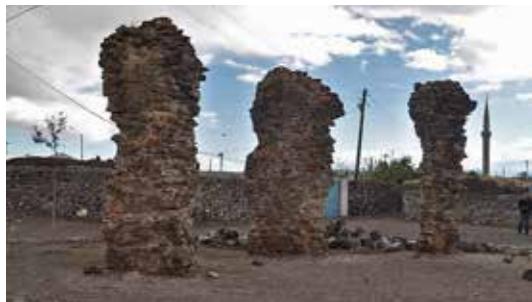
Sometime in the 1880s the locals incorporated the half-preserved church into a new one, and it remained in this condition until 1920. Today, after being mostly destroyed, only remnants from

the rubble of three pylons are preserved. The mausoleum has an entrance underground but it is currently filled with mud.

Matrix Group 2—Possible eventual action. The site requires archaeological investigation. Remains of the church's pylons must be preserved, and the mausoleum needs conservation.

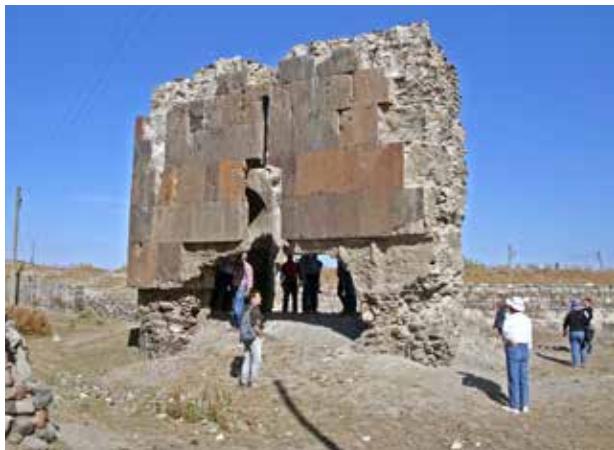
The structure is in a dangerous condition with only two walls partially remaining.

Matrix Group 2—Possible eventual action. What remains of the church requires conservation work. The structure should be propped in areas where the support walls are missing as an emergency measure until more permanent repairs can take place. The surviving part of the monument needs to be measured and archaeological excavation at the site is also necessary.

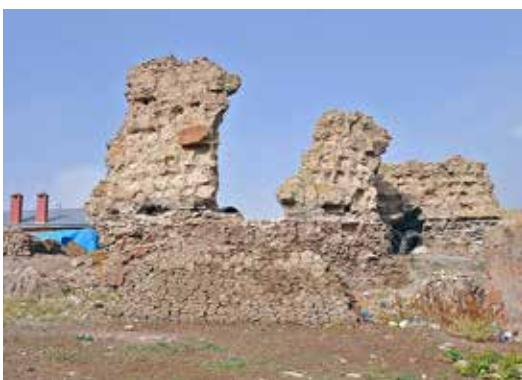
The church was partially damaged by an earthquake at the end of the nineteenth century and it was later completely demolished, probably in the 1950s. Little remains of the church, which has been scavenged by the village. Currently, only the rubble core of a single wall remains, used to house chickens and other possessions belonging to the villagers. There are also signs and stories of illegal excavations.

Matrix Group 2—Possible eventual action. The territory of the former church needs to be cleaned from villagers' household activities and undergo archaeological examination. Remains of the church need delicate conservation and the structure should be propped in areas where the support walls are missing as an emergency measure until more permanent repairs can take place.

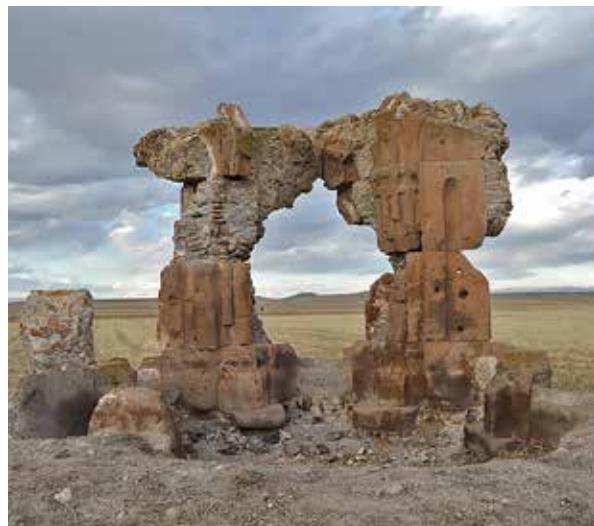
All that remains of the church and baths are the foundations, part of the northern side of the first-story wall, and the lower portions of two of the eight pillars that originally composed the walls. There are signs of illegal excavation on the outer side of the foundation walls.

Matrix Group 2—Possible eventual action. The site needs archaeological examination, the remains of the building must be conserved, and the structure should be propped in areas where the support walls are missing as an emergency measure until more permanent repairs can take place.

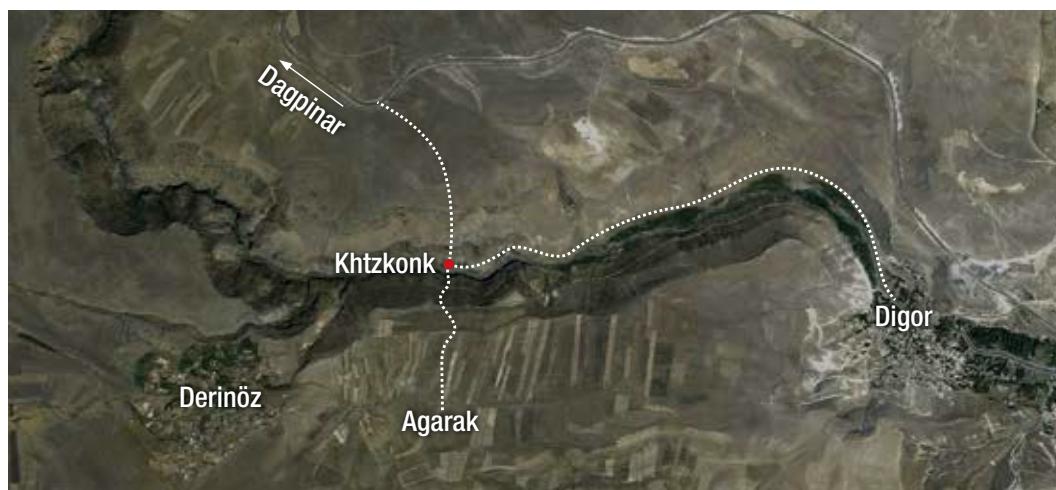
FIGURE 1.

Khtzkonk is not currently vehicle-accessible, but there are three main ways to access the site (Figure 1). The first option is to walk west from Digor's town center through the gorge for approximately 4.5 kilometers. The first half of the walk is through fields, and then up onto the right bank of the gorge for the rest of the way. There is no road or pathway in the fields. The second option is along a mountain path that leads from the road between Dagpinar and Digor. The path is barely visible up through the mountain and in some areas is obstructed by fallen rocks. Difficulty level of access is medium-high. Access is also limited by seasonal conditions. The final option is to access the site from the ancient settlement of Agarak, located south of Khtzkonk. The descent is more difficult but the total travel time is significantly reduced using this route.

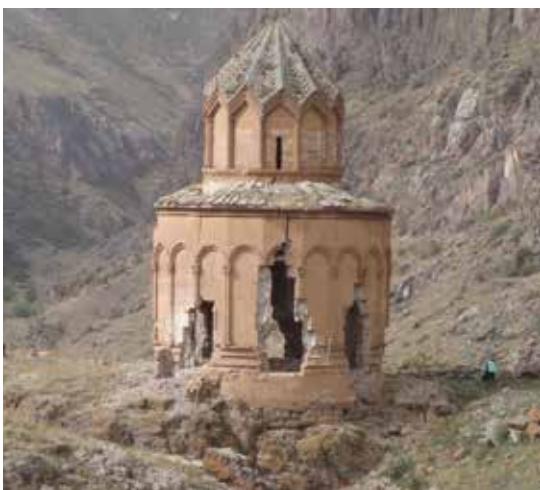
FIGURE 4.

In 1950 the monastery was deliberately destroyed. The monastic buildings and four of the churches disappeared almost completely, leaving only Surb Sargis today (Figure 4.).

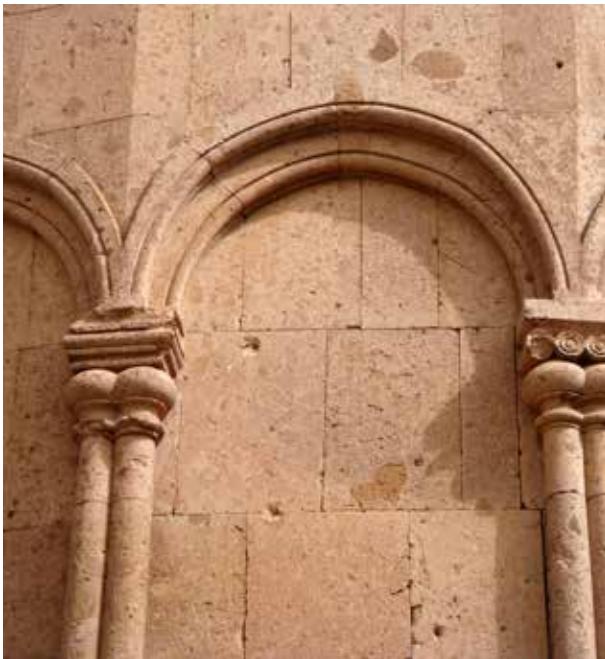
FIGURE 7.

Two other decorative features of Surb Sargis deserve note here. First, the capitals of the colonnettes, on both interior and exterior. The capitals of the lower tier of arcading are topped with abaci of four circular forms, which project into cylinders toward the surface of the church (Figure 7). This form of abacus may be seen as a development from the stylized Ionic capital known from other examples of Armenian church architecture. A nearby form, but more closely related to the Ionic order of capital from whence it was derived, may be found in the capital program of the now-ruined church of Gagkashen, at Ani.

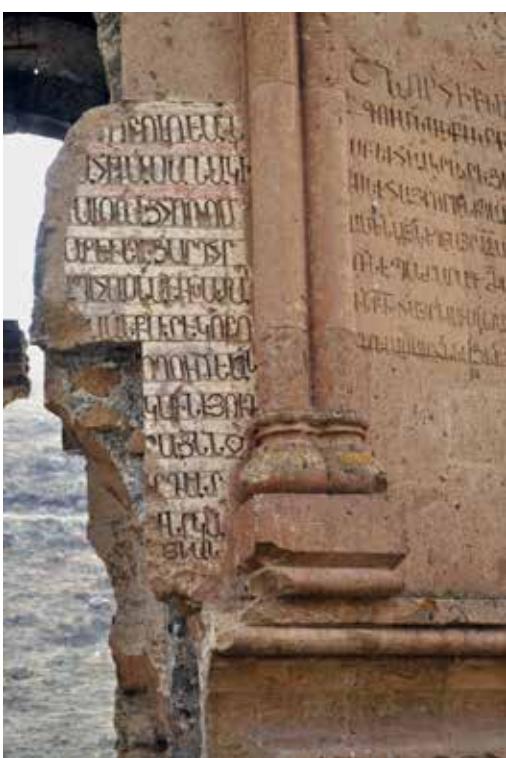
FIGURE 9.

The exterior of Khtzkonk is covered in inscriptions that record both the many restorations and the donations made to the monastery (Figure 9). These texts are fascinating because they demonstrate the social, political, and economic interconnection of the elites in the region, and give immediate meaning to the concept of “Ani in Context.” For example, one of the inscriptions indicates the gift from a certain Brnavor, “servant of Christ,” and his wife Tgha of a vineyard at Mren called Aghtotn (“the Dirty”).

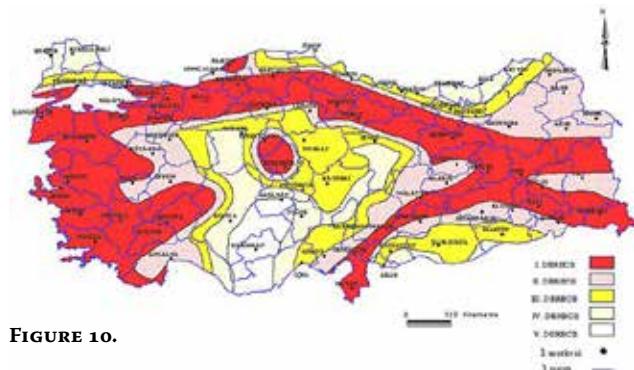
FIGURE 10.

Since 1924, ten destructive and semi-destructive earthquakes have been reported in the region. The first earthquake occurred on May 13, 1924, affecting Sarıkamış, southwest of Kars. The severest earthquake, with a 6.2 magnitude, occurred in Digor on May 1, 1935. This earthquake affected all the settlements in a 50 kilometer radius.¹ According to newspaper accounts, almost all the houses were destroyed, monuments were severely damaged, and there were many deaths and injuries. Digor and its surroundings experienced 10 aftershocks from this earthquake.² Digor had a series of earthquakes in 1936, 1938, 1941, 1962, 1972, 1975, 1976, and 1983. The district was seriously affected by the 1988 Erivan earthquake. The magnitudes of these earthquakes were 4.5 to 6.9 M_s.³ The buildings not repaired and maintained were completely demolished during these earthquakes.⁴ Landslides and falling rocks are also frequent dangers in this area.

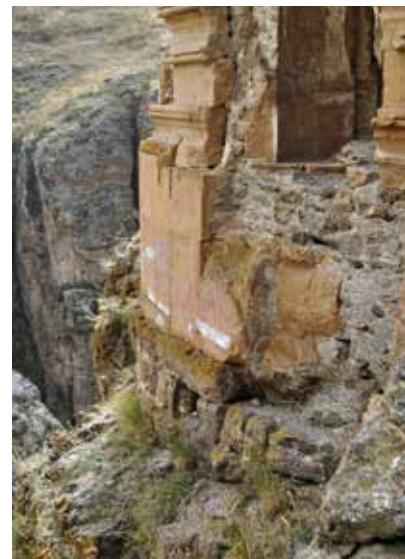
FIGURE 11.

The foundation, composed of three courses of stone, is exposed on the east side and reveals that the structure is set on undisturbed stone (Figure 11). It was customary in antiquity for the building masters in seismic areas to avoid resting foundation walls directly on the rock to avoid resonance during seismic events. It is hypothesized that these three courses

of stones are laid all through the floor to serve as a mat foundation as is found beneath Roman, Ionian, and Byzantine monuments.

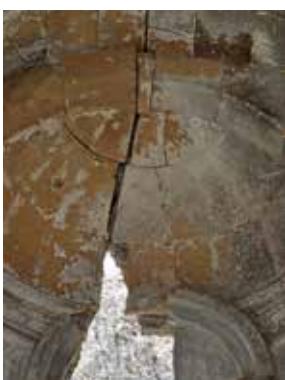
FIGURE 14.

Three of the four conch cracks have reached the base of the dome but have not propagated into the dome (Figure 15). Some of the interior stones at the base of the lower cylinder are missing (Figure 16). There is a hole in the apex of the dome. It was observed that some of the stone units at the apex of some of the vaults leading to the top of each conch are loose and could fall to the ground (Figure 17).

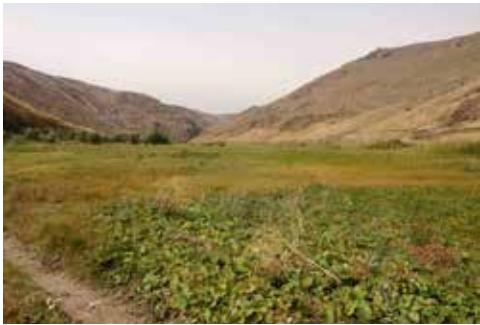
FIGURE 26.

- The fields at the entrance to the valley are arable and fertile, and are harvested three times per year (Figure 26). Deeper into the gorge, the rocky topography and narrowness of the land prevents agricultural use. There are shepherds and sheep farming around the rocky areas surrounding the monuments. The stream below also has fish (Figure 27).

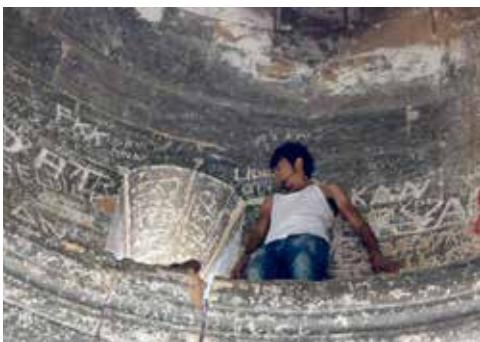
FIGURE 28.

- Graffiti, fire, and illegal excavations are a threat to the remains of Surb Sargis. Charred fire remains within the church are most likely left by the local shepherds for either cooking the fish they catch from the stream or for heating purposes. Local youngsters climb up to the walls and the dome easily since there is no security or control at the site. (Figure 28)

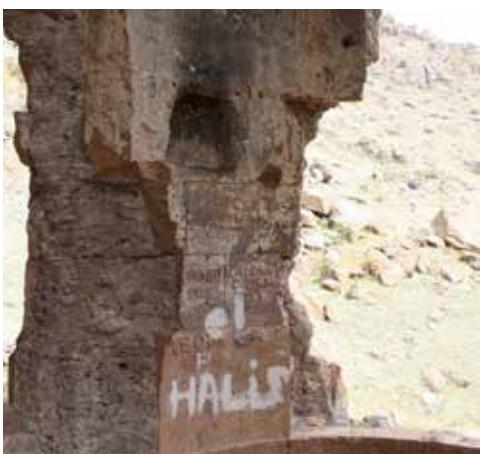
FIGURE 29.

- There are indications on the ground that some illegal excavations were done by treasure hunters. Some of the walls of the standing church were most possibly destroyed while the treasure hunters were searching for the “gold,” or just due to acts of vandalism. (Figure 29)
